Oppdragsgiver <i>Client</i> Nortek AS Vangkroken 2 1351 Rud		Utførende enhet/lab. <i>Department/laboratory responsible</i> Teknologisk Institutt as Environmental Test Laboratory P.O. Box 1019 NO - 3601 KONGSBERG	
Rapportnr. <i>Report no.</i> 3000-16-024152			
Tittel <i>Title</i> Environmental Test Report Vibration test Signature 250			
Dato <i>Date</i> 14.06.2016	Utarbeidet av <i>Prepared by</i>

The Environmental Test Laboratory at Teknologisk Institutt AS has performed vibration test on Signature 250 S/N: D-0214 for Nortek AS. The test was performed 13.06.2016 and 14.06.2016.

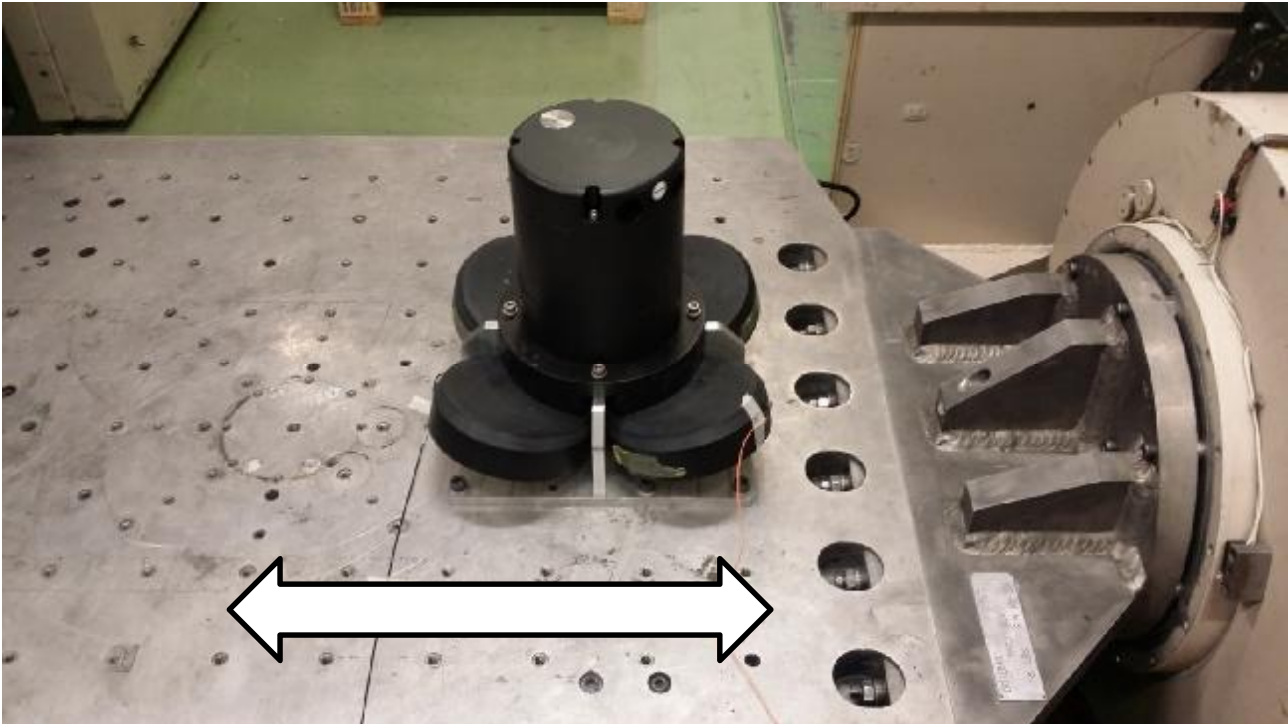
Figure 1 - Test item placed in X-axis

The environmental test equipment used during test with calibration status and measurement uncertainty figures is given in Appendix 1. The test item were mounted on the shaker as shown in figures 1, 4 and 7. The test item were not powered during test. A visual inspection was performed after test. Functional test was performed at Nortek after test. The positions of control and response accelerometers are shown in figures 2, 3, 5, 6, 8 and 9.

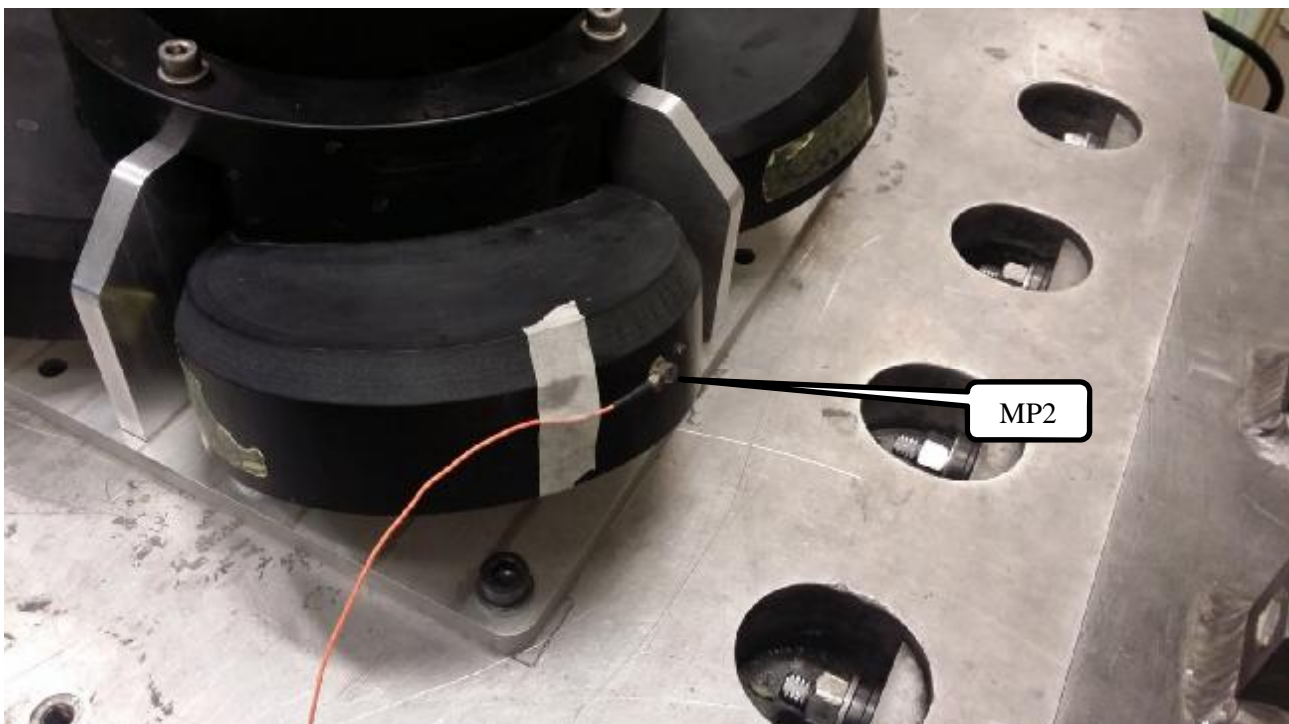
Figure 2 - MP2 in X-axis

MP2: Response accelerometer on test item.

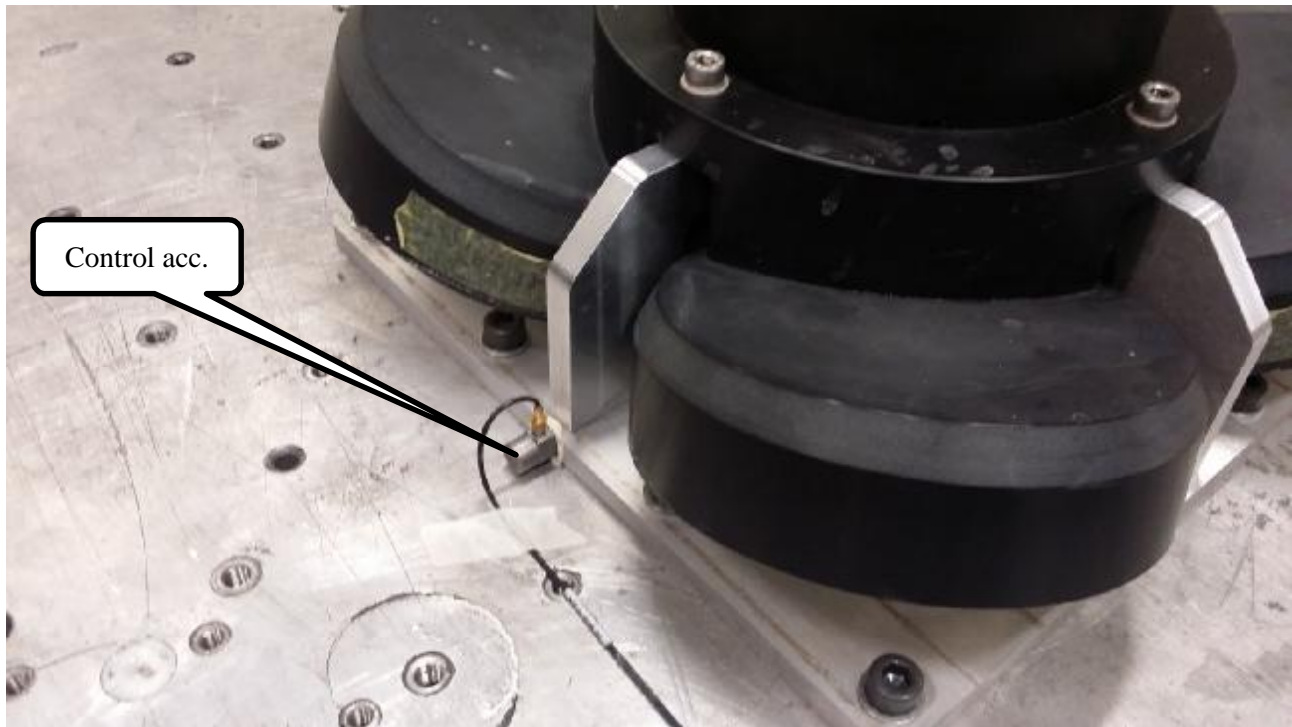
Figure 3 - Control accelerometer in X-axis

MP1: Control accelerometer.

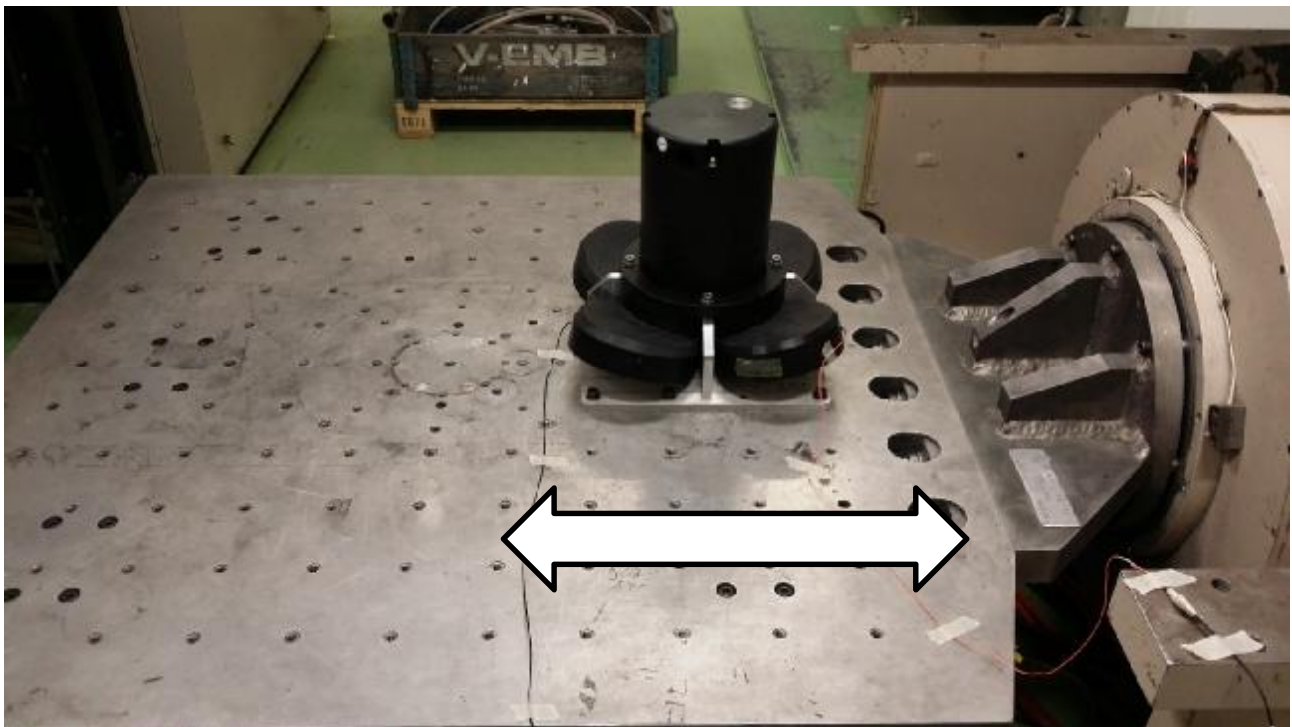
Figure 4 - Test item placed in Y-axis

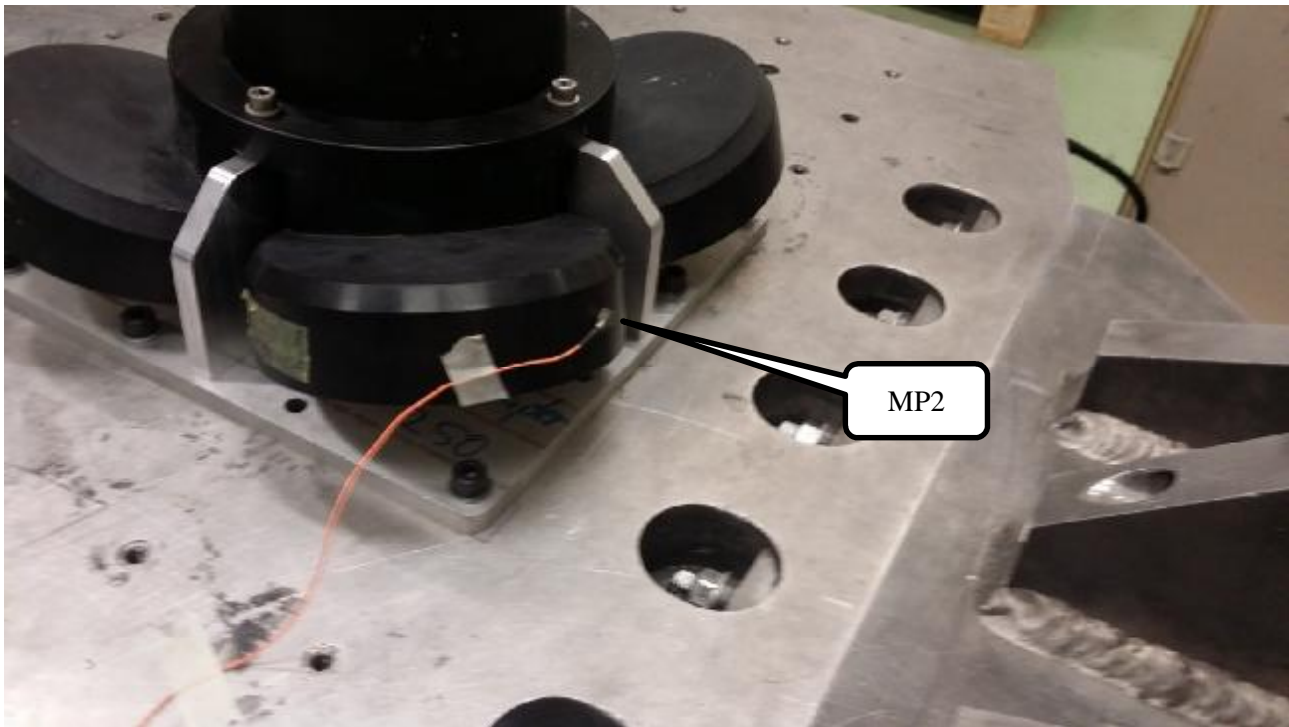
Figure 5 - MP2 in Y-axis

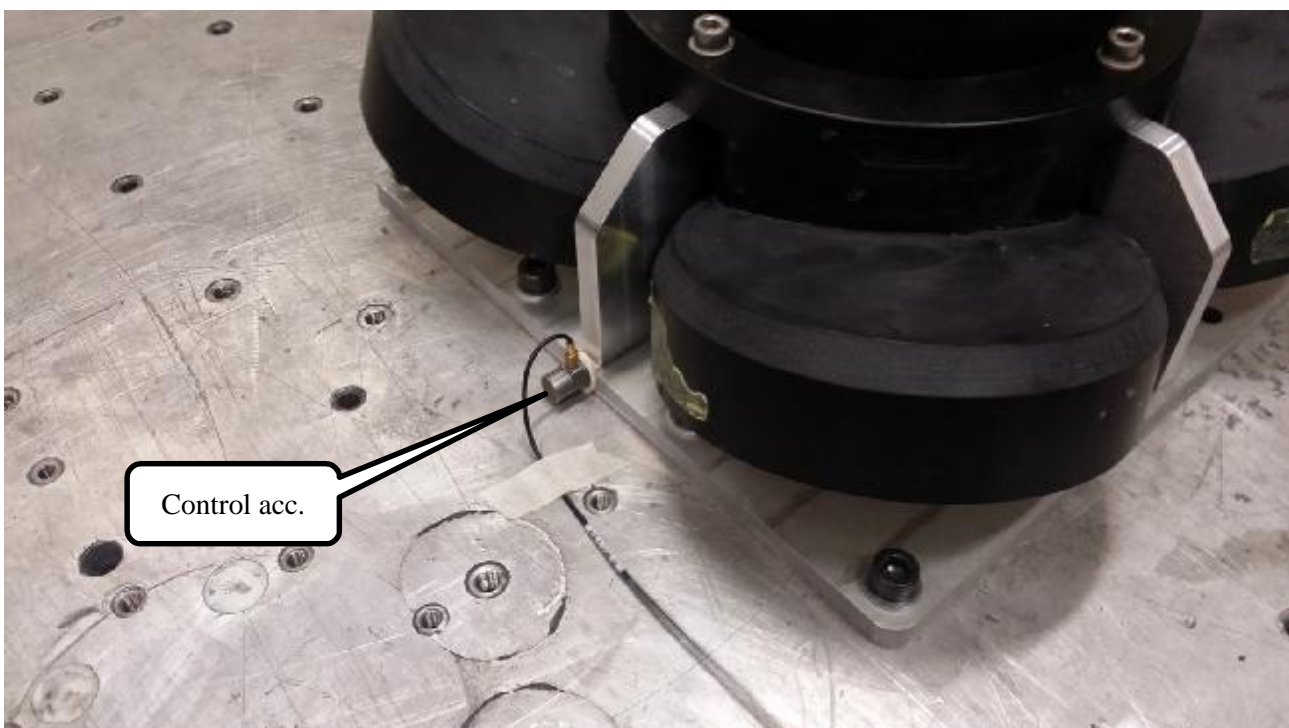
Figure 6 - Control accelerometer in Y-axis

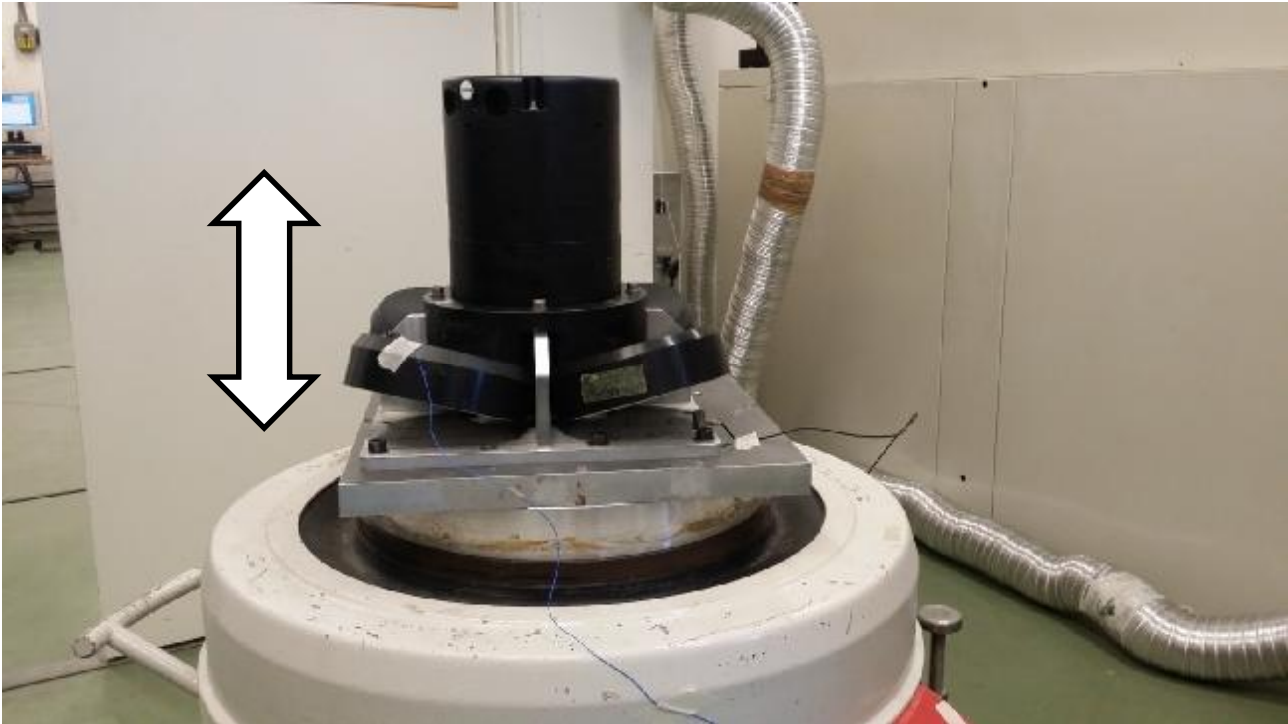
Figure 7 - Test item placed in Z-axis

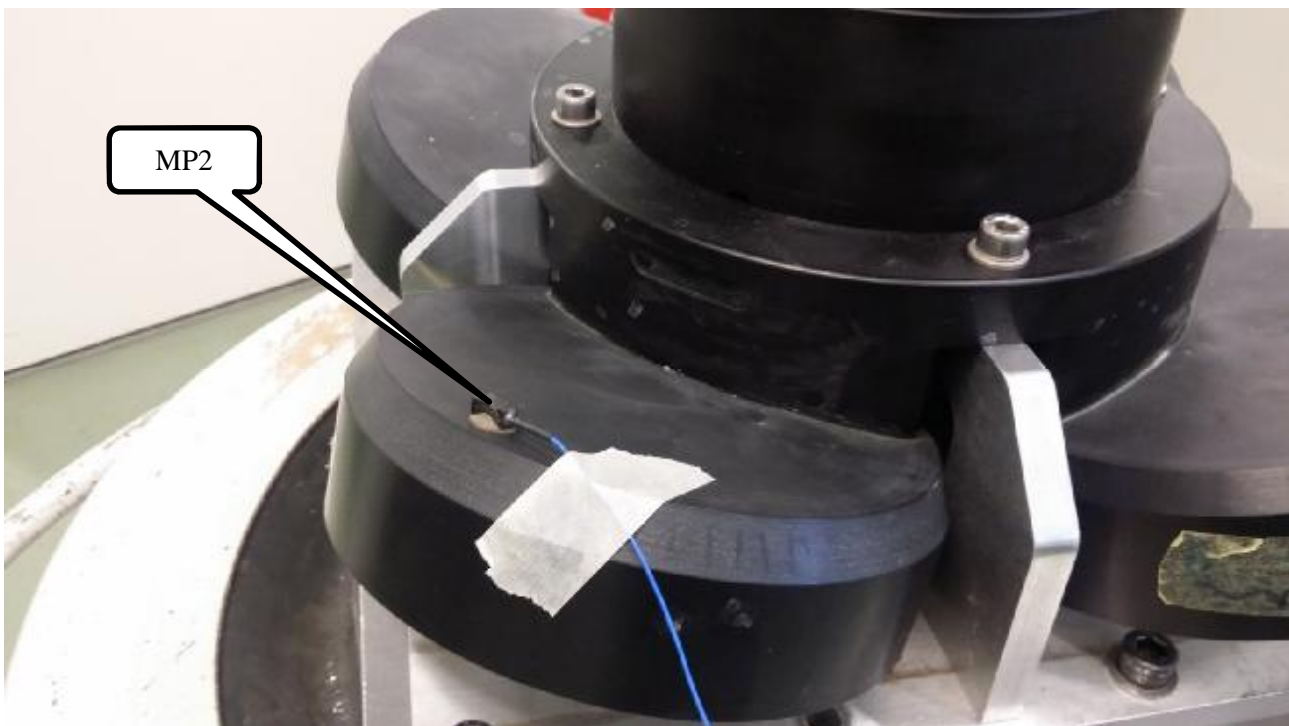
Figure 8 - MP2 in Z-axis

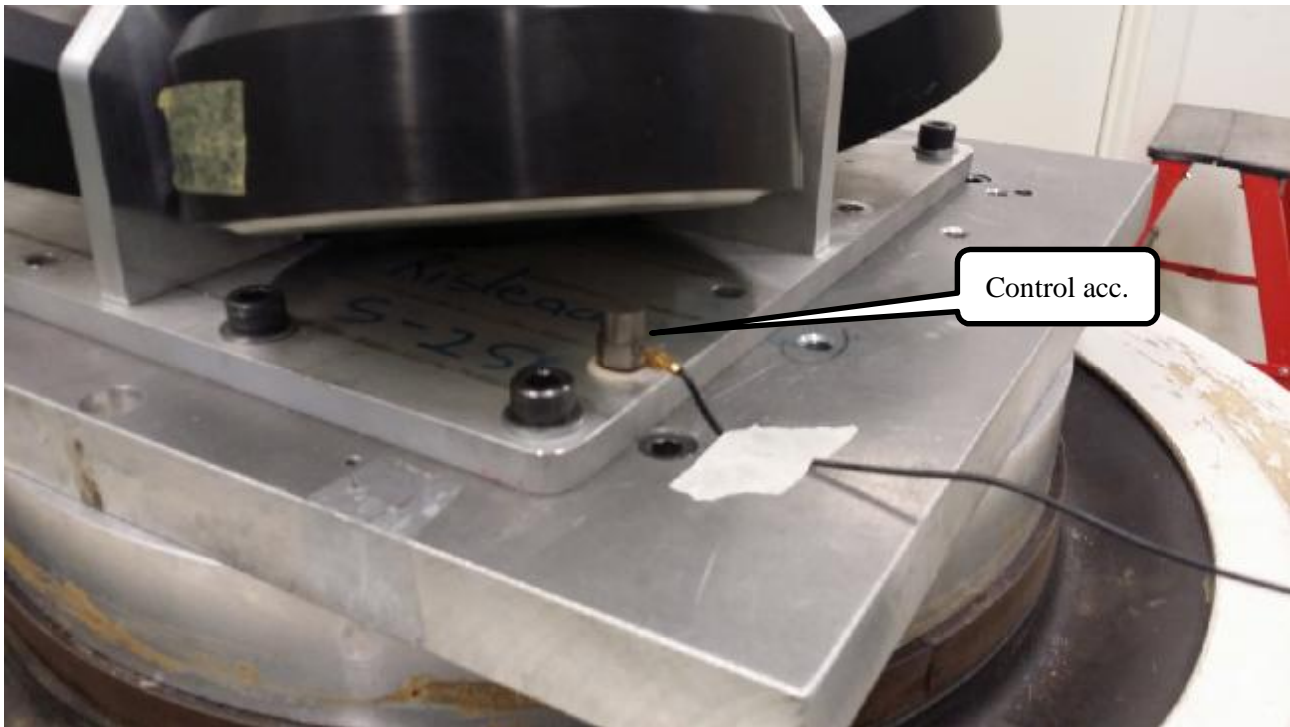
Figure 9 - Control accelerometer in Z-axis
